# Exploring Physical and Human Induced Coastal Morphodynamics: A Study with Reference to Nintavur to Addalaichenai Coastal Areas of Ampara District, Sri Lanka

Article in *Academic Journal of Interdisciplinary Studies* · May 2021

Received: 11 February 2021 / Accepted: 22 March 2021 / Published: 10 May 2021

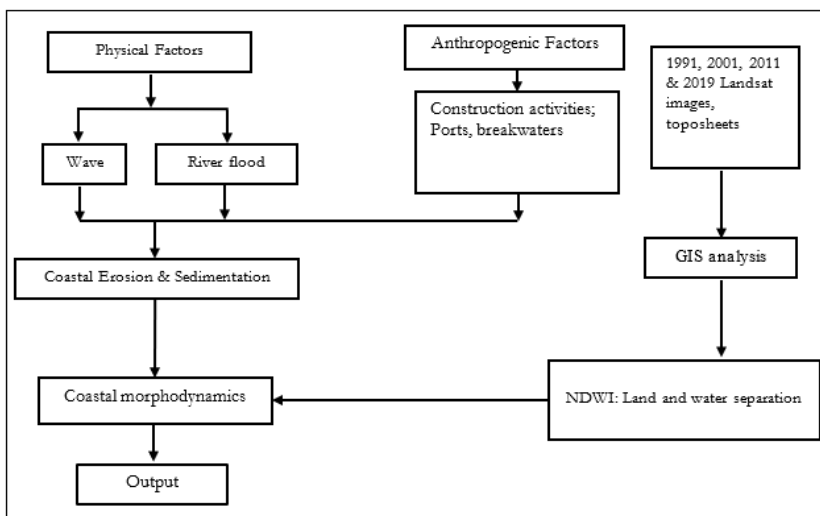
**Figure 02:** Methodology framework

Water and land indices were separated using NDWI calculation (Sarker et al., 2013). NDWI was processed to separate the land and water properties from the satellite images. This process was performed to the all the satellite images of 1991, 2001, 2011 and 2019. Then, the shorelines where the land and water properties are interacting were distinguished. Shoreline of 1991 satellite image was considered as the baseline on which rest of the extracted shorelines were compared. Then, they were overlaid with the view to find the delineation of coastal morphology from the baseline according to the figure 02.

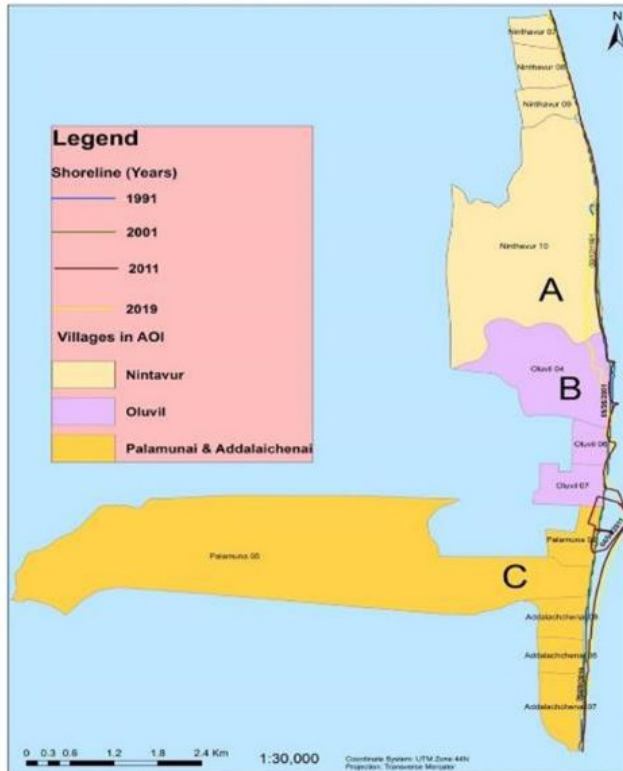
**Figure 03:** Periodic coastal morphodynamics in the years of 1991, 2001, 2011 and 2019 in the study area  
**Source:** Retrieved from Arc GIS 10.4

Figure 03 shows the 03 divisions of the study area, divided as A, B and C with the view to clearly show the morphological changes. The coastlines of the years 1991, 2001, 2011 and 2019 were overlaid to show the periodic coastal morphological changes. Thus, coastal morphodynamics have been found in many locations of the study area because of the wave action and river flooding in the years of 2001 and 2011 but, mammoth change in the coastal morphology has been identified in the year of 2019, which is the period of post harbor construction in Oluvil area.

It was found that the sedimentation and erosion have been recorded South and North ward of the port respectively. Further, the rivers, emptying into the Sea during the flooding period, cause morphological modifications, in particular to the river mouths which tangent to the beach.

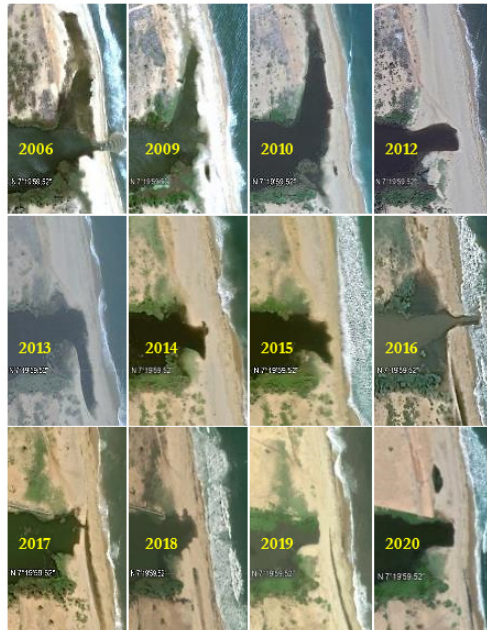
The figure 05 shows the coastal morphological changes in *Wavvalodai* river mouth which is located in *Nintavur* village. When flooding of the river, the overflow through the *Wavvalodai* river out of the river breaks the sandbars, across the river. In this situation, the river mouth is getting modified because of the erosion and transportation of the sand and soil. It is apparent that in the years of 2006 and 2016, the river water flow broken the sandbar across the river mouth. In other years, the river flooding has widened the river mouth in multi-directions.

**Figure 05:** Periodic coastal morphodynamics in Wavvalodai river mouth, Nintavur Village

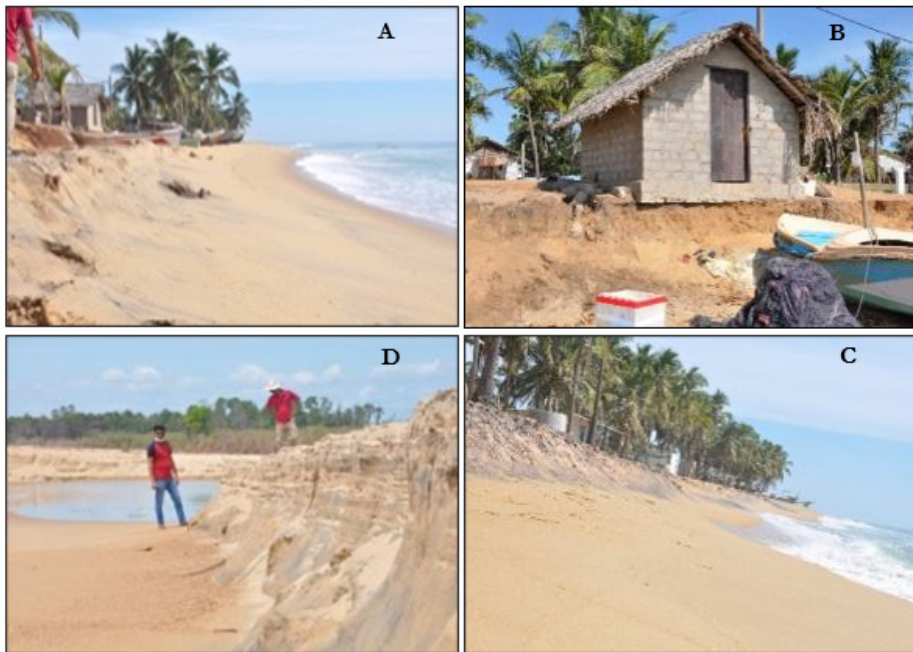
**Figure 07:** Coastal area of A; *Nintavur-07*, B; *Nintavur-08*, C; *Nintavur-09* & *Nintavur-10* GNDs

Figure 07 depicts the scenario of the *Nintavur* beach and how the shoreline has been modified because of the perennial wave action and periodical river flooding. A huge extent of the land has been eroded and transported from one place to another. This situation is leading the beach for getting shrinkage.

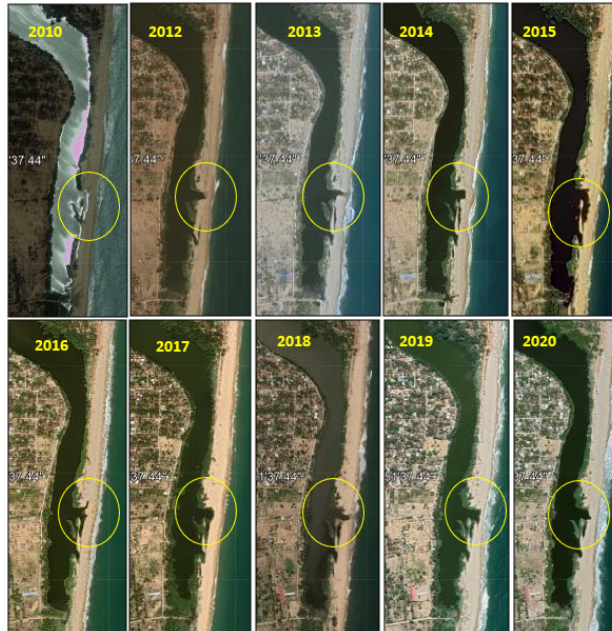
Figure 12 shows the coastal morphological changes in *Konawatta* river mouth, *Addalaichenai* area. The increased flow of water in *Konawatta* river breaks the sandbar across the river. This situation also makes changes in the coastal morphology of the river mouth inner and outer scales of the sandbars.

The encircled areas on the images are the places where the river water frequently breaks the sandbars and causing the morphological changes and, in some instances, the inhabitants widen the river mouth to drain the storm water to the Sea. Eroded river mouth and consequent changes of the beach have been shown in 2012, 2013 and 2018 GE images.

Figure 12: River mouth morphological changes of *Konawatta* river

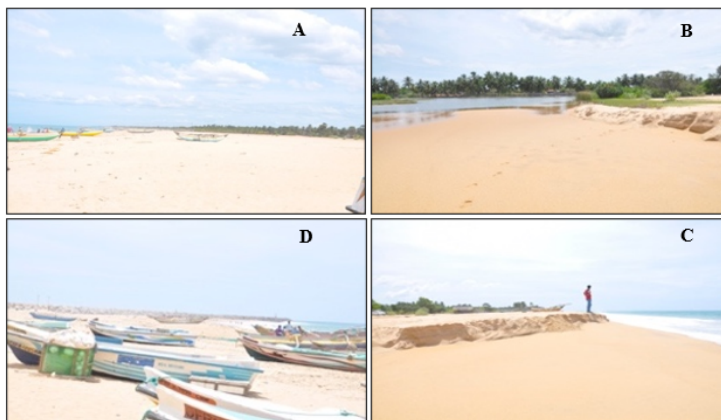
Figure 13: A; *Palamuanai-02* GND, B & C; *Konawatta* river mouth D; Southward of the port

The figure 13 exhibits the present situation of the *Palamunai* and *Addalaichenai* coasts where voluminous sedimentation formed. In particular, *Palamunai* area which is immediately closed to the port in Southward direction has experienced anomalous sedimentation effect.
